# Design Guidelines: Cornices & Friezes

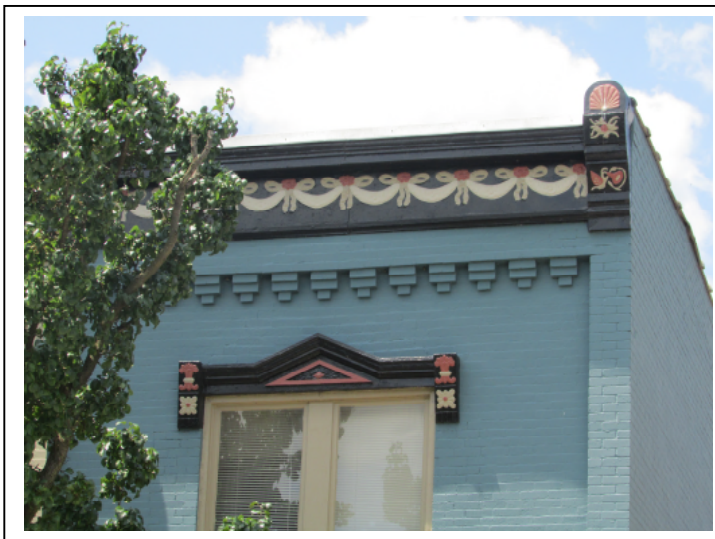
*The ornate metal cornice – as well as the decorative brickwork below – is a key architectural feature for this North Capitol Avenue building. The multicolor paint scheme serves to highlight the detail.*
